Double Walls

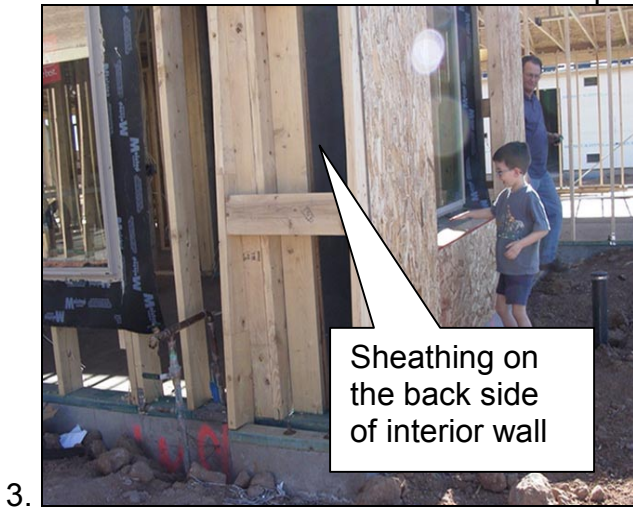
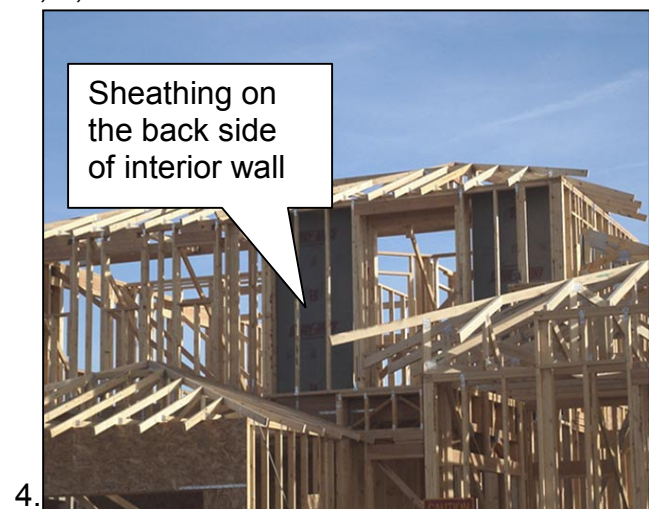
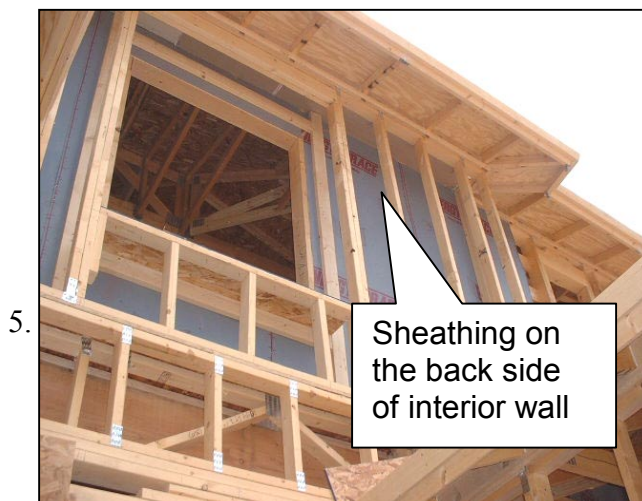
The easiest way to ensure this wall will not contribute to air leakage and insulation failure is to place rigid sheathing such as oriented strand board (OSB), plywood, sheetrock or Thermoply™ on the back side of the interior wall as shown in pictures 3, 4, and 5.
